FULL MOUTH REHABILITATION OF SEVERELY WORN DENTITION WITH LOSS OF VERTICAL DIMENSION- A CASE REPORT

Dr. Rajdeep Tah, Dr. Ahila Singaravel Chidambaranathan, Dr. Muthukumar Balasubramaniam

Department of Prosthodontics, SRM Dental College, SRM University, Ramapuram, Chennai, India.

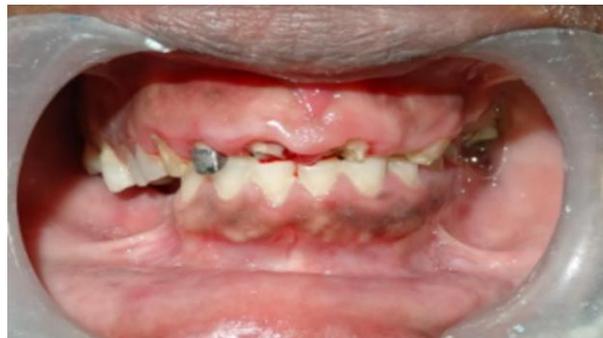
A 65 years old male patient reported to the Department of Prosthodontics, SRM Dental College, Ramapuram, Chennai, India with the complaints of severely damaged teeth with difficulty in chewing and sensitivity. On clinical examination 12, 24,25,26,27 are missing in maxillary arch, classified as Kennedy’s class III partial edentulous space and 44,45,46,47,35,36,37 in Mandible, classified as Kennedy’s class I partial edentulous space. The clinical condition is coming under Turner’s category No 1: Excessive wear with loss of vertical dimension of occlusion¹[Fig.1]. Treatment plan explained to the patient was cost post on 11,21,12 with long span FPD from 16 to 28 and root canal treatment for the mandibular teeth with FPD in relation to 43,42,41 and 31,32,33,34,35 with removable partial denture for distal extension space. The treatment procedure was started after obtaining informed consent from the patient.

Fig 1: Pre-operative (Intra-oral view)

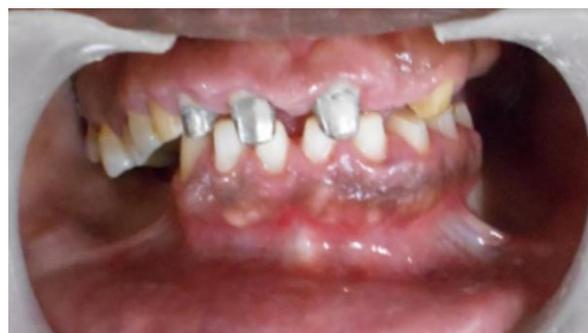
Fig 2: Coping fixed on the abutment teeth 11, 21

After root canal treatment of maxillary anterior teeth, cast post was done on 11,21,12 [Fig.2] then temporary crown was fabricated using tooth color acrylic.(Dental products of India).A lucia jig with 2 mm thickness was fabricated using auto polymerized acrylic resin (DPI, India).Then tooth preparation was done on lower anterior teeth ,the bite was registered with Bonabite bite vinyl polysiloxane registration paste (DMP, Europe)[Fig.3] and mounted in a semi-adjustable articulator Hanau spring bow (R-035203).The wax pattern for temporary crown was fabricated [Fig.4] and duplicated with silicone putty material (Aquasil, Dentsply Intl, New York, PA).Tooth preparation for all the remaining teeth had been done [Fig.5] and jaw relation was done with the lucia jig and mounted in semi-adjustable articulator.

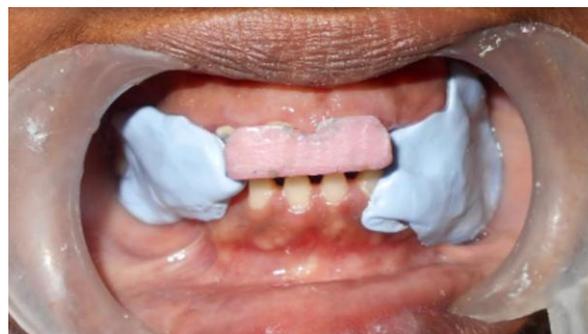
Fig 3: Inter-occlusal record with Lucia Jig

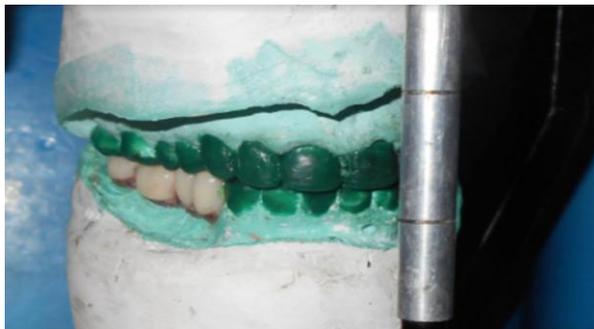
Fig 4: Wax Pattern for provisional restoration

In the articulated with an increased OVD, the occlusal plane was established with Broad-rick occlusal plane analyzer. This plane was used as a guide during mock wax-up. The mock wax-up was used for putty index from which the fabrication of temporary restoration was done. Then the provisional restoration was fabricated using tooth color acrylic resin.(Dental products of India) and luted with intermediate restorative material.(IRM, Dentsply, India)[Fig.6].

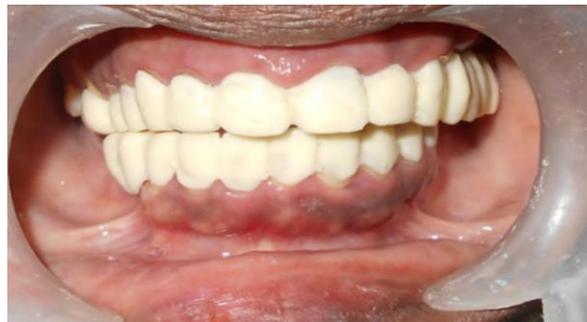
Fig 6: Provisional restoration

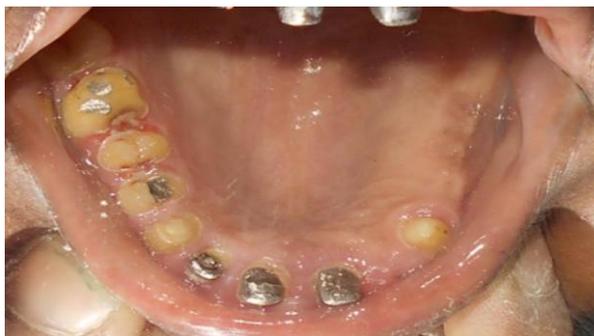
Fig 5: Tooth preparation of maxillary teeth

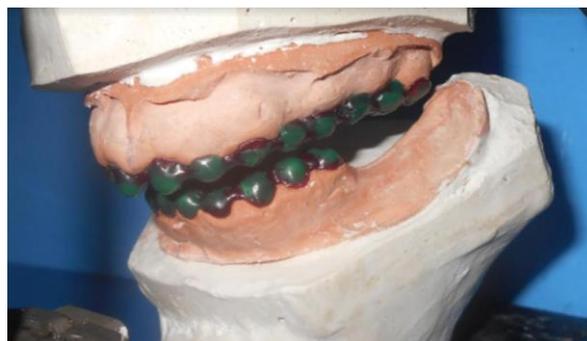
Fig 7: Wax pattern for metal coping

Then wax pattern for final restoration was done using casting wax.[Fig.7] and casting and finishing was done. Metal try-in was done to verify the fitness and retention of the prosthesis.[Fig.8]Ceramic build-up was done [Fig.9] and cemented with glass ionomer (GC Corporation, Tokyo, Japan).[Fig.10]

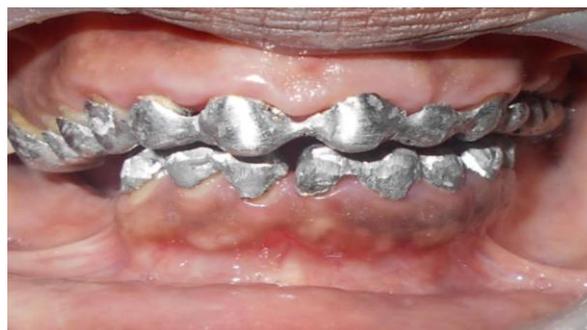
Fig 8: Metal coping

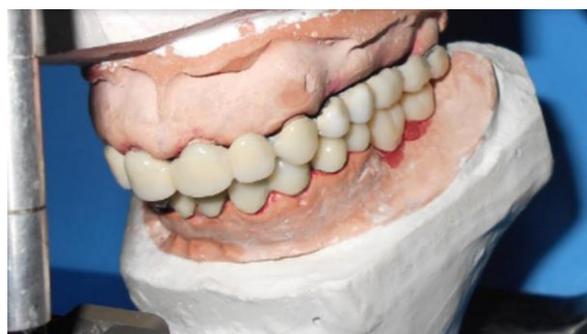
Fig 9: Final Prosthesis

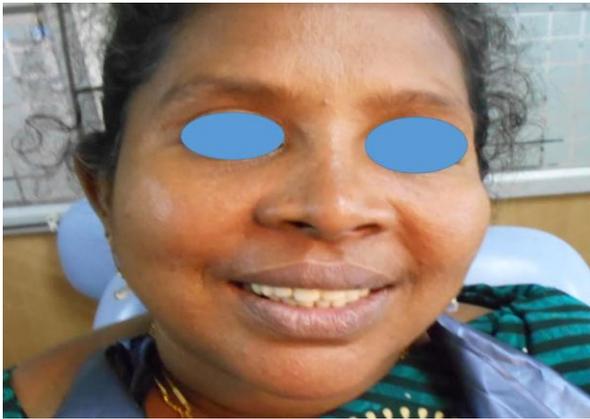
Fig 10: Post-operative (extra oral view)
